Case Study: Plant Worsens Slip Rings by DIY Grinding

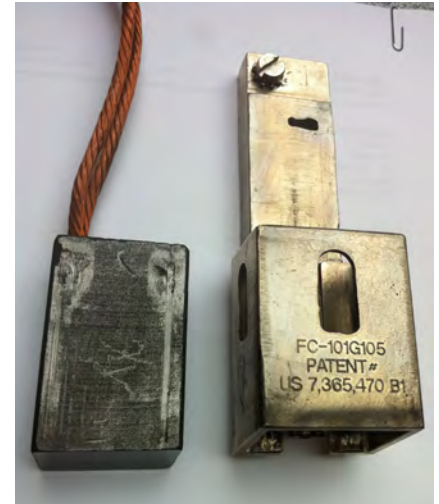
Despite frequent brush holder cleaning, brush binding was taking place in the brush holders. This binding causes brushes to not make proper contact with the slip rings. Electrical erosion then takes place on the ring surface creating low spots. This is evidenced by increased brush vibrations, photographing on the rings and binding markings on the brushes. The plant did not feel that the holders were failing because of their attention to maintenance and their (inaccurate) belief that pulling on the brush leads during operation proved the brushes were not binding. The grinding of the rings by plant increased the depth of the low spots on the ring and caused the sudden increase in vibrations. Fortunately the plant was taking vibrations readings during their attempt to true the rings and they stopped before catastrophic failure resulted. When Cutsforth arrived on site amperage readings on the brushes showed multiple brushes were conducting less than 5 amps and some were even reading 0 amps. Pulling on the brush leads of those brushes would result in a temporary return to normal current flow until the brush would soon bind again. Slight arcing of the brushes and photographing of the slip rings returned to the generator as well.

1. Cutsforth Online Truing: Cutsforth Online Truing process was completed on both rings bringing all brush vibrations to under 1 mil. The slip rings were brought back into round creating a smooth running surface for the brushes and eliminated arcing. Cutsforth has 20 years experience of bringing slip rings back into round while generators are online and under full load.
