Case Study: “Photographing” of Collector Rings

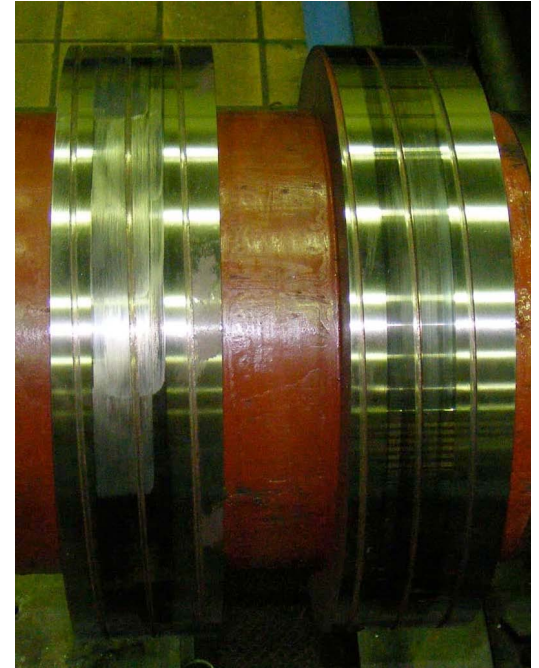
A large, privately owned company in the southeast U.S. had a 35 MW turbine generator undergo a major rotor overhaul. During this major, new collector rings and new after market, cartridge-style, plug-in holders were installed by a contractor. These new holders were recommended and sold to the plant by an independent sales representative. Within 6-months after startup, the plant experienced photographing (also called imaging, ghosting or footprinting) and arcing on both polarities on the collector rings. The plant notified the contractor for support and was advised that the problem was with the brush holders and directed the plant back to the sales representative. The sales representative advised the plant that the holders were installed incorrectly and directed the plant back to the contractor. The contractor disagreed and blamed the brush holders. Plant personnel were caught between the sales rep and the contractor. The brush holder manufacturer was contacted and told the plant that the installation was to blame. The plant adjusted all the brush holders with no improvement. The independent representative eventually recommended the plant purchase “surface rounding brushes” to address the problems. The plant purchased and installed the rounding brushes until the photographing and arcing disappeared. Within weeks both the arcing and photographing returned. The plant continued to install the rounding brushes weekly. After nearly a year of operation in this manner, an unplanned outage occurred and inspection revealed that some locations of the rings, had up to 0.090 inches of metal removed. The plant was never able to get support from the contractor or independent representative at solving the ongoing arcing and photographing problems and contacted Cutsforth for a long-term solution.

Photographing occurs as a result of a compromised brush-to-ring connection. Photographing that is not removed, can worsen and eventually lead to out-of-round rings with increased brush vibrations. This compromised connection occurs by brushes becoming stuck or bound within the brush holders. The cause of the stuck brushes on this unit was a combination of carbon deposits, weak springs and severe brush binding which compromised the brush-to-ring connection.

1. Cutsforth Groove Restoration: Cutsforth’s patented groove restoration process was completed on both rings to bring the helical groove back to the recommended depth. This prevented the plant from having to replace and install new collector rings. This saved the plant thousands of dollars and the need for an extended forced outage.
2. Cutsforth Online-Removable Brush Holder System: Cutsforth holders were installed on the unit to eliminate severe brush binding, spring issues and carbon deposit buildup that occurred on the previous aftermarket (and OEM recommend) brush holders.
3. Cutsforth Online Truing: Cutsforth then trued (ground) the rings after the unit was brought back online and loaded. This removed the remaining photographing on the rings from the prior holders, smoothed the rings surface to enable proper filming, and ensured brush vibrations were within an acceptable range.
